◀ BEST PRACTICE INFORMATION ▶

Protection of concrete flexi-hoses

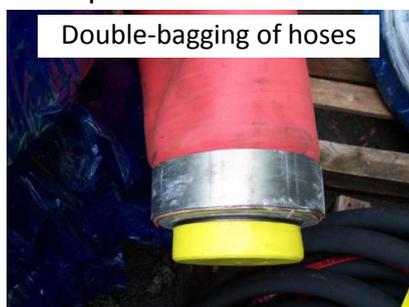
- 1) **An additional layer of protection.** Whilst double-bagging is effective, it prevents easy inspection of the hose. An alternative is shown on the right which allows for visual inspection of the hose.

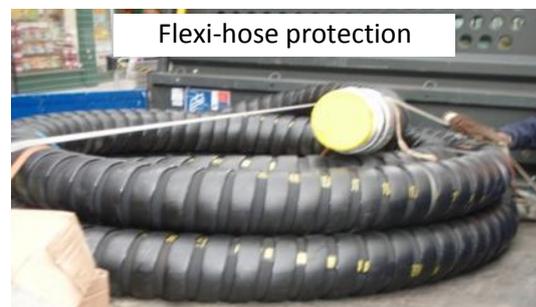
- 2) **Protection of hoses from site traffic.** Some examples are shown below, however the overall outcome should be the prevention of contact between vehicle traffic and hoses (whether under pressure or not), minimising risk of damage.
